**Device** TC1798/93/91, TC1748  
**Marking/Step** ES-AB, AB  
**Package** see Data Sheet

## 02698AERRA

This Errata Sheet describes the deviations from the current user documentation.

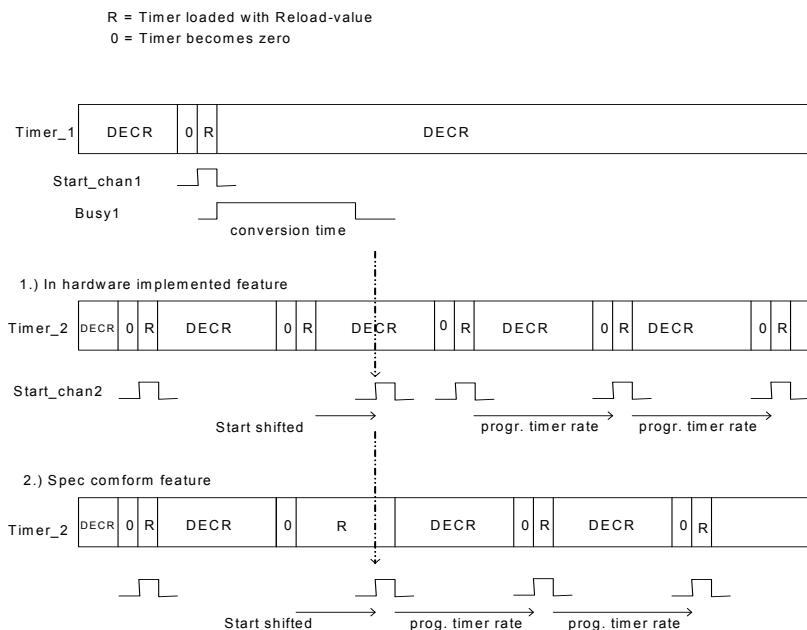
**Figure 1 Timing concerning equidistant multiple timers**

The correct behavior would be a reload when the requested conversion (of channel\_2) is started.

Therefore the start of conversion for channel\_2 is delayed by maximum one conversion-time. After this delay it will be continued with equidistant conversion-starts. Please refer to the following figure.

Note: the programmed timer rate is much longer than the conversion time, this means that the fault is much smaller than in the picture

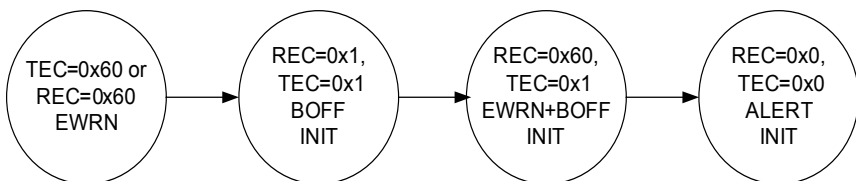
**Figure 2 Alert Interrupt Behavior in case of Bus-Off**

The MultiCAN module shows the following behavior in case of a bus-off status:

When the threshold for error warning (EWRN) is reached (default value of Error Warning Level EWRN = 0x60), then the EWRN interrupt is issued. The bus-off (BOFF) status is reached if  $TEC > 255$  according to CAN specification, changing the MultiCAN module with REC and TEC to the same value 0x1, setting the INIT bit to 1<sub>B</sub>, and issuing the BOFF interrupt. The bus-off recovery phase starts automatically. Every time an idle time is seen, REC is incremented. If REC = 0x60, a combined status EWRN+BOFF is reached. The corresponding interrupt can also be seen as a pre-warning interrupt, that the bus-off recovery phase will be finished soon. When the bus-off recovery phase has finished (128 times idle time have been seen on the bus), EWRN and BOFF are cleared, the ALERT interrupt bit is set and the INIT bit is still set.

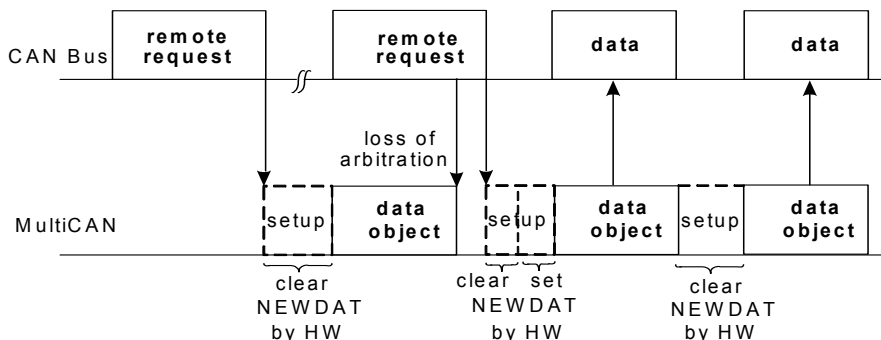
**Figure 3 Loss of Arbitration**

When the appropriate message object (data frame) triggered by the first remote frame wins the arbitration, it will be sent out and `NEWDAT` is not reset. This leads to an additional data frame, that will be sent by this message object (clearing `NEWDAT`).

There will, however, not be more data frames than there are corresponding remote requests.
